FATIGUE BEHAVIOUR OF A ROLLED AZ31 MAGNESIUM ALLOYS PREPARED BY EP AND BB CONDITIONS

Abstract: Rotating bending fatigue tests have been performed using smooth specimens of a rolled AZ31 magnesium alloy in laboratory air at ambient temperature. Fatigue strength and characteristic was evaluated and fracture mechanism was discussed on the basis fracture surface analysis. Electrical polishing (EP) as well as deep rolling (ball burnishing (BB)) U-notched specimens were performed on two groups of samples, to evaluate optimum conditions for fatigue life. The microstructure and tensile properties of roll cast (RC) Mg- 3% Al- 1% Zn (AZ31) was investigated. The fatigue strength of 107 cycles around 100 MPa for deep rolling while it was around 40 MPa for Electrical polishing. It was very important to understand the effect of (ball burnishing (BB)) conditions on the hardness of the surface through to the core. The two procedures improved the fatigue performance, but better improve in results were found in ball burnishing. The growth of small cracks initiated at the surface coincided with the FCP characteristic after allowing for crack closure for large cracks, but the operative fracture mecha

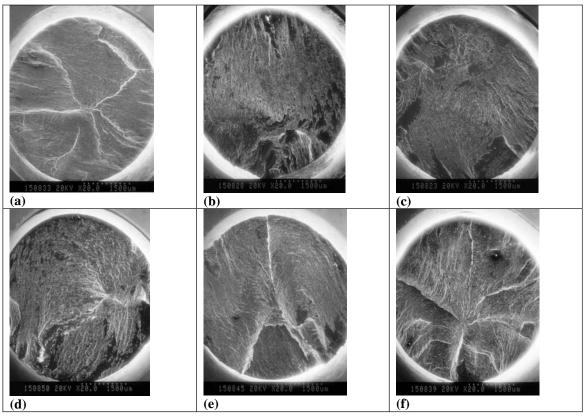
Fig.4. SEM micrographs showing fracture surfaces at difference stress for EP at (a) 60MPa; (b) 80 MPa; (c) 100 MPa and BB at (d) 60MPa; (e) 80 MPa; (f) 100 MPa.

The fracture surface of AZ31 for EP condition and BB condition at different stress is shown in Fig.

4. Subsurface crack initiation occurred at applied stresses at 60 MPa. At BB condition but it can be seen for both 80 and 100 MPa stress for EP condition. The S–N diagram is shown in Fig. 2. It is well known that fatigue limit does not exist in non-ferrous alloys, thus fatigue tests were continued until 10^7 cycles. At EP condition σ = 40 MPa, fatigue failure did not occur, but non-propagating cracks were observed on the specimen surface. As can be seen in the figure, the present Mg alloy seems to possess a definite fatigue limit, which may be related to the existence of non-propagating cracks. The fracture mode depending

on applied stress level, above 60 MPa cracks initiate at the surface (surface fracture), while below that stress at the interior of the specimen (subsurface fracture). Subsurface fracture is a very interesting finding, which has not been recognized in Mg alloys, for both EP and BB conditions.

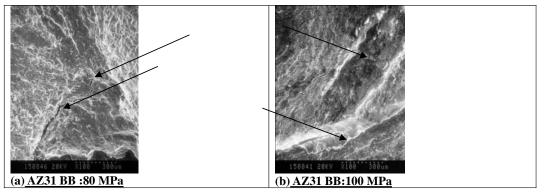
Fig. 5. SEM micrographs showing cracked surfaces at difference stress for BB at (a) 80MPa; (b) 100 MPa

The cracked line could be seen easily for higher stress for BB condition as fracture occurs in internal surface not at the outer surface as in the EP condition in Fig. 5.
